REPORT 257

Variable Ship Speed and Usable Life Tests of Nylon-Coated, Surface-Vessel, Bathythermograph Hoisting Cable

L. B. STARK ENGINEERING SERVICES DIVISION

U. S. NAVY ELECTRONICS LABORATORY, SAN DIEGO, CALIFORNIA

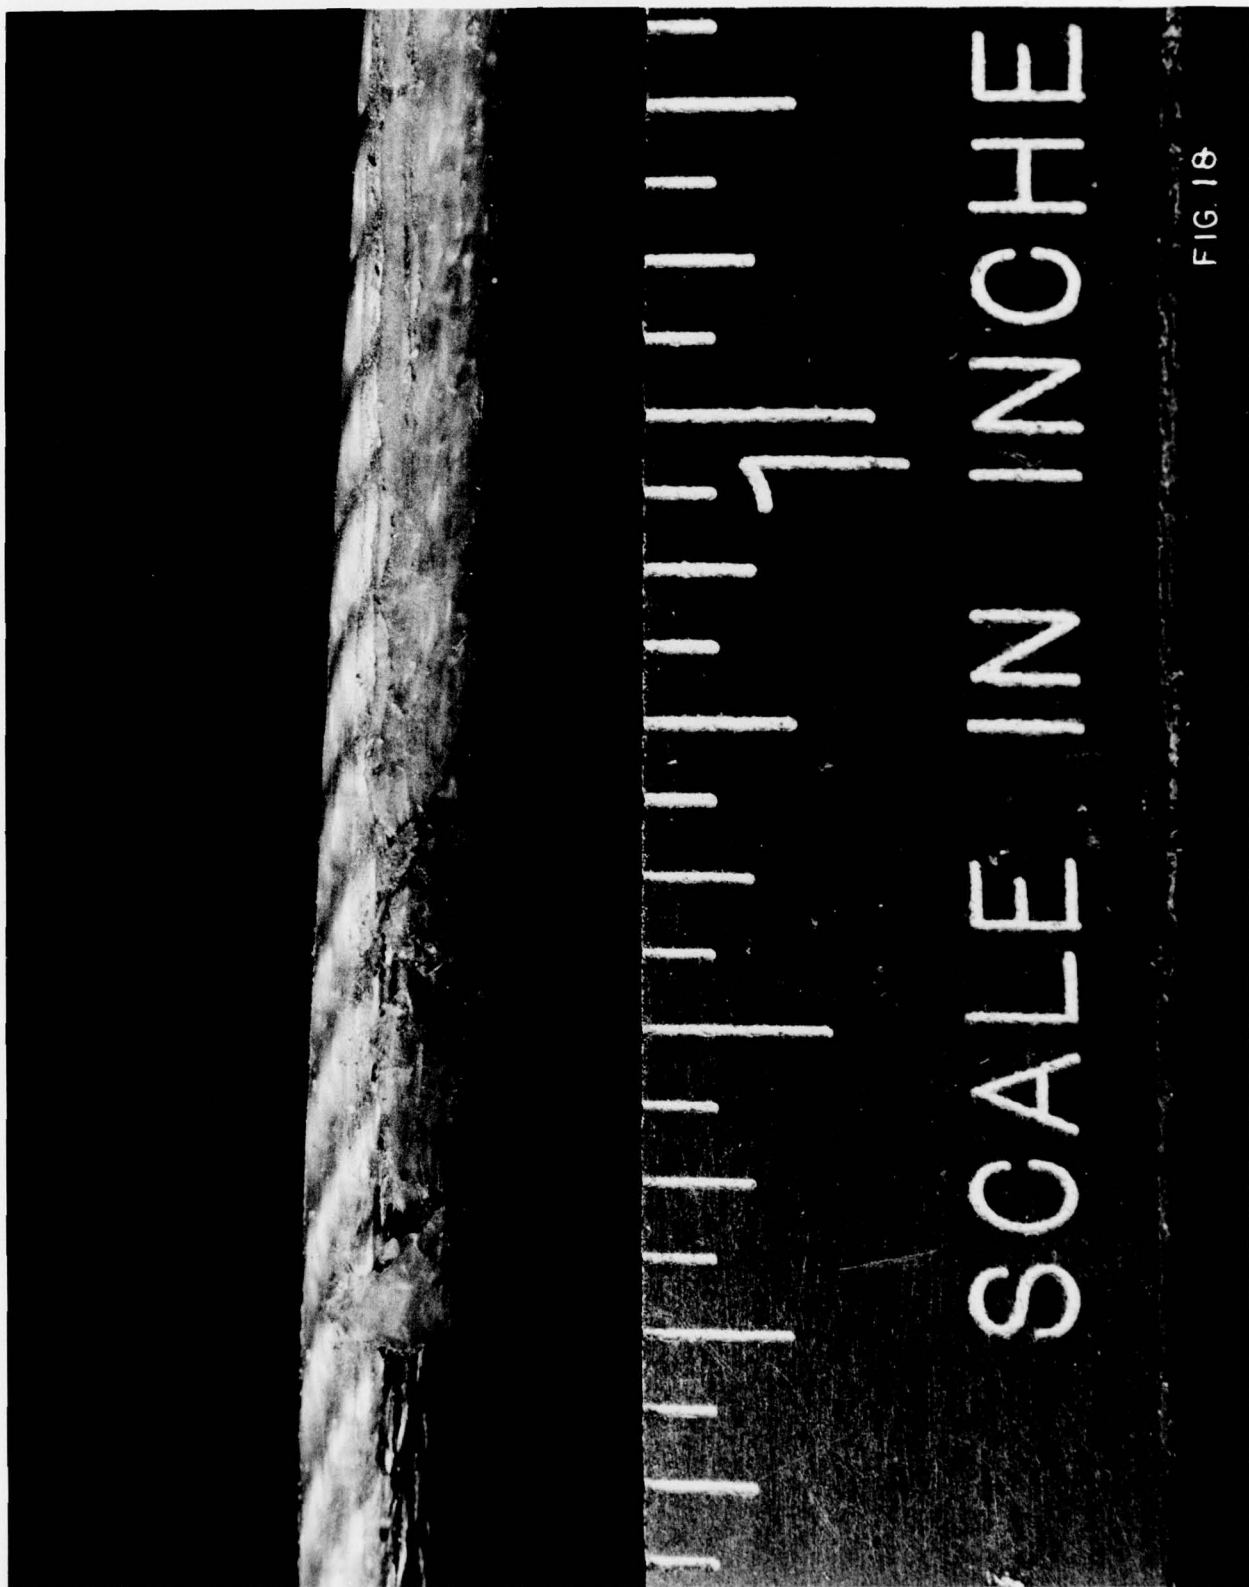
FIG 18

Types of coating failures restricted to a small area are shown in figures 17, 18, and 19; in most cases these failures did not lead to further damage which impaired the use of the cable. The fibrous peeling indicated in figure 17 appears to have been caused by localized abrasion and, in practically all cases, the fibrous peeling tore away from the remainder of the coating without further serious coating damage. Figure 18 shows a small, sharp transverse cut of a type which did not usually cause the coating to peel. Figure 19 is representative of a localized tear, most examples of which did not extend over 3/8 in. in length and often did not reach the wire core. All of the coating failures shown in figures 17, 18, and 19 are indicative of the generally higher durability of the 1/32-in. nylon coating as compared to the 1/64-in. coating shown in figures 1 through 13. These less severe failures occurred approximately 180 feet from the bathythermograph end of Cable 2.

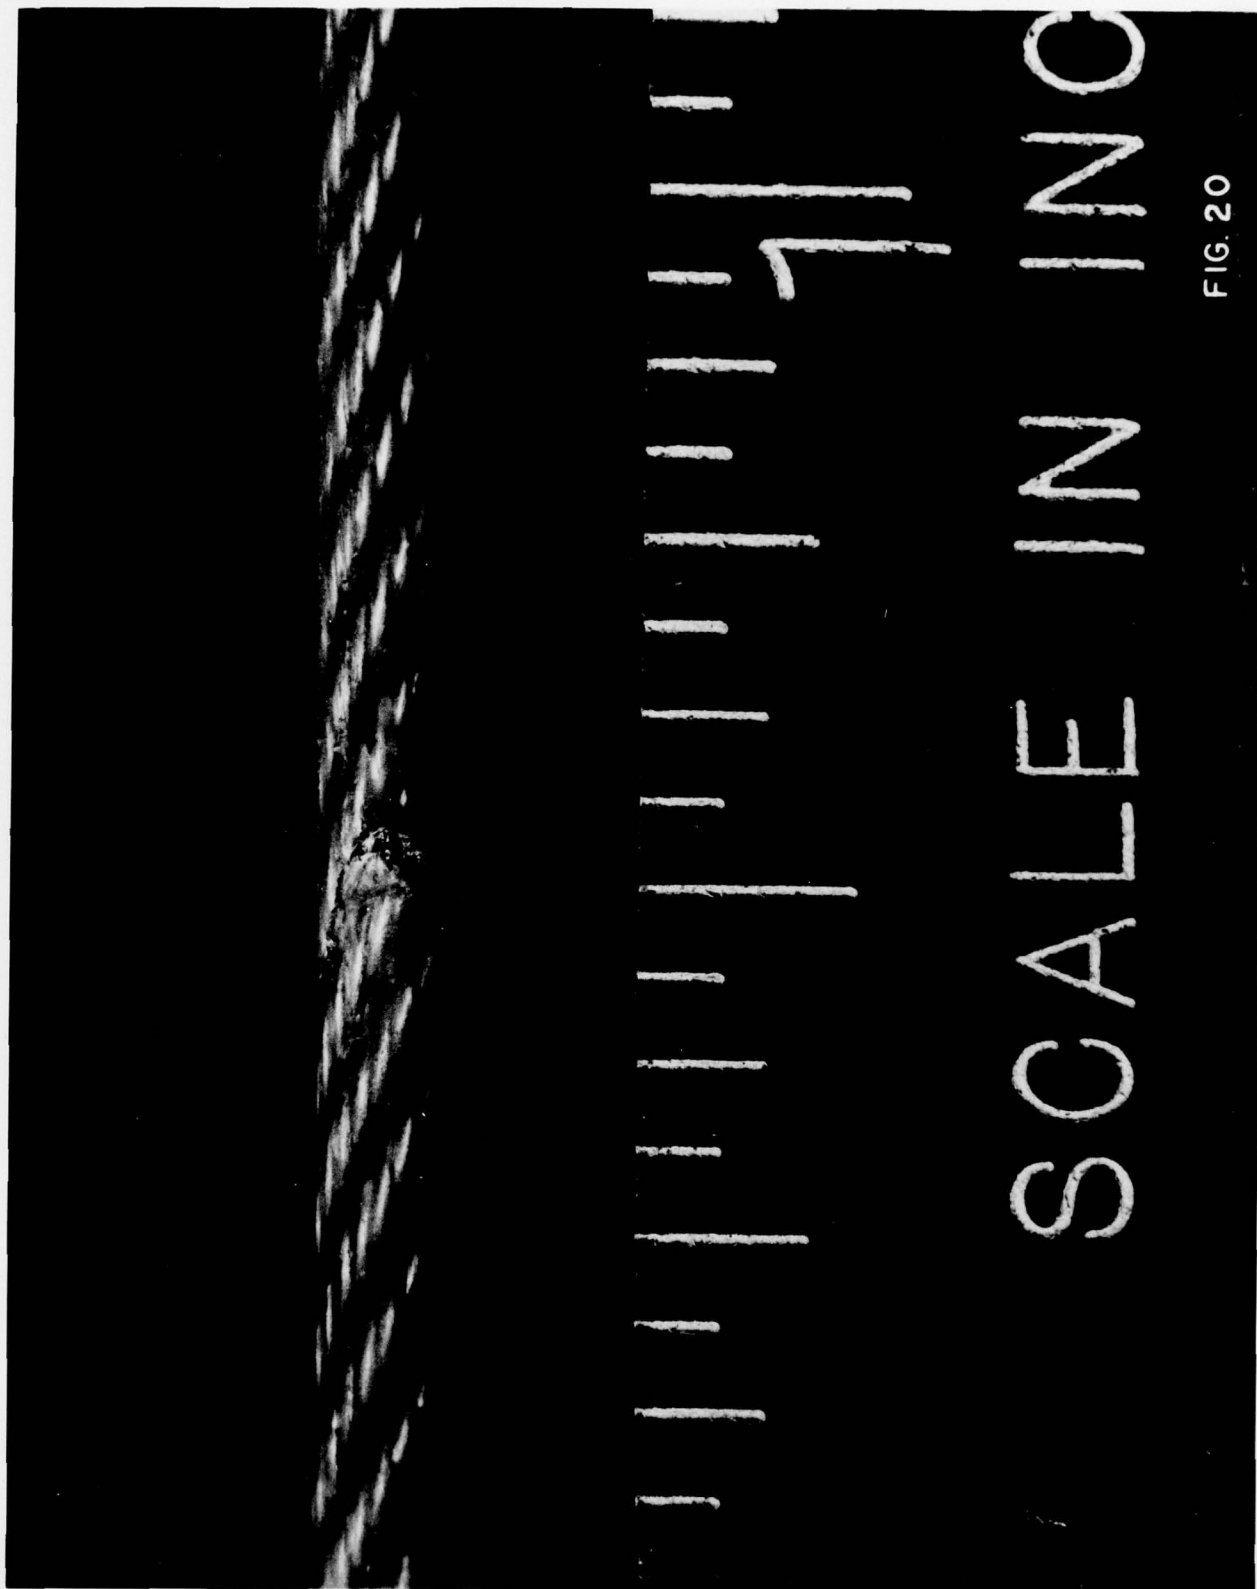
FIG. 20

Figures 20, 21, and 22 are examples of miscellaneous failures that occurred occasionally in Cable 2 from 150 to 190 feet from the bathythermograph. The small surface cut shown in figure 20 occurred frequently, indicating that the nylon coating is quite susceptible to surface nicks by any sharp object. It is nevertheless important to note that surface cuts of this type did not usually lead to progressive coating failures or peeling of the coating from the wire core. Figure 21 shows a type of surface abrasion failure of the 1/32-in. nylon coating, which generally consisted of the intermittent tearing out of chunks in the surface layer of short sections (1/2 to 1 in.) of the nylon coating. Although these abrasions do not add materially to severe coating failures, cumulatively they tended to roughen intermittently the cable coating surface over fairly large linear distances (50 to 100 feet) in the areas closer to the bathythermograph

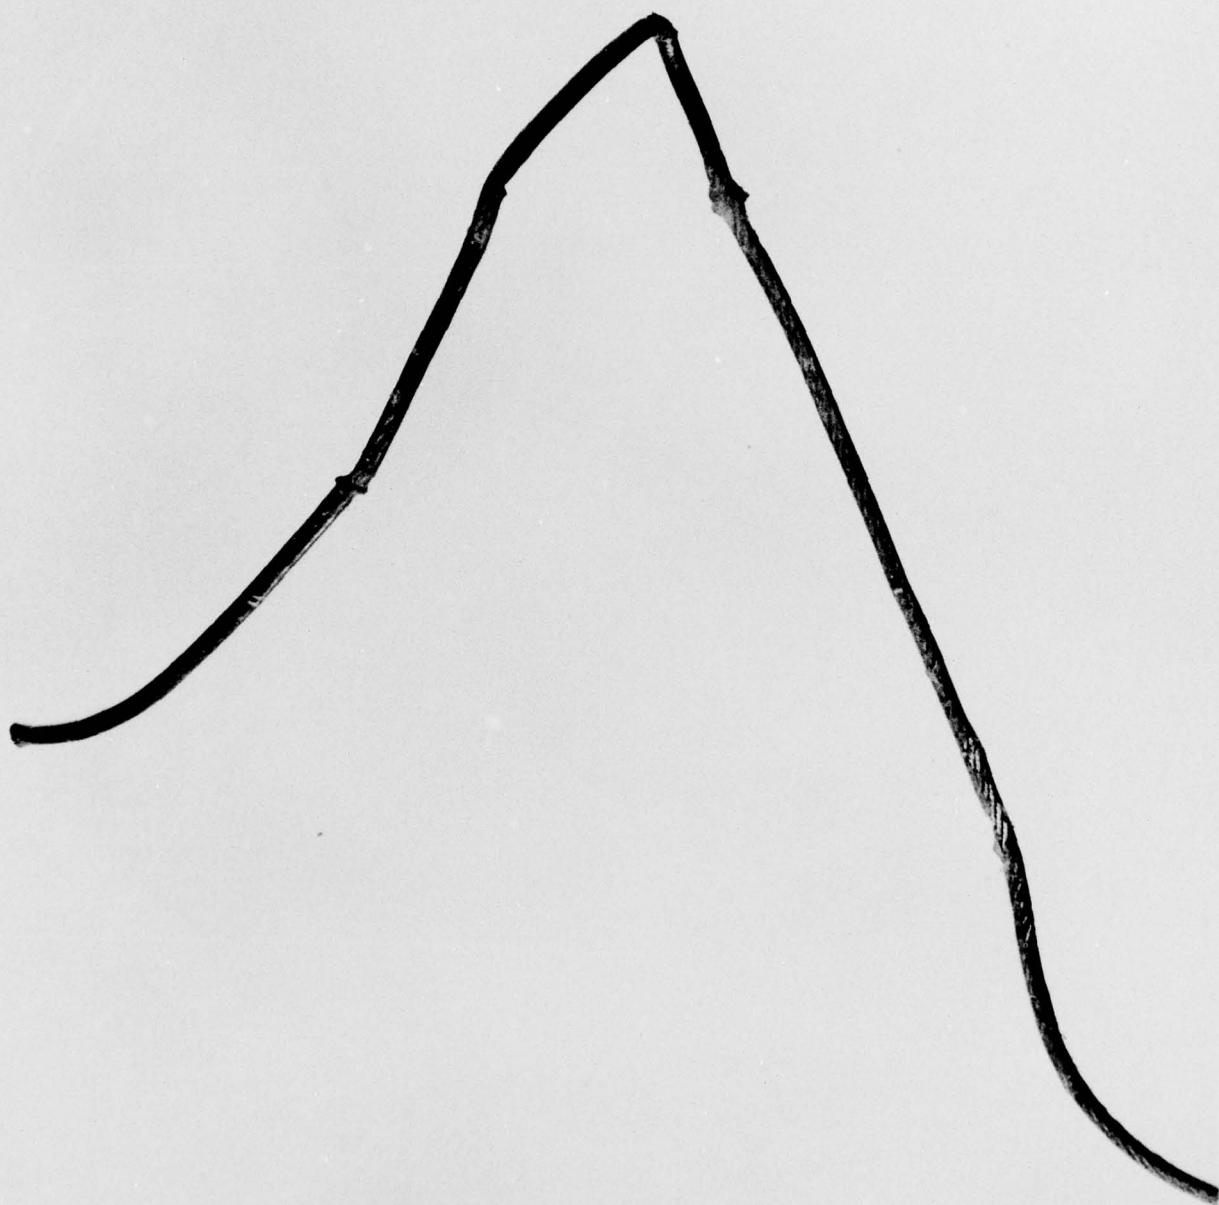
FIG. 22

end. The results of moderate to sharp kinks over short lineal distances on Cable 2 are well illustrated by the coating failures shown in figure 22. It is evident that some transverse "pile-up" of the nylon coating results from the severe longitudinal strains caused by the kinks. In general, these transverse points of coating distortion are not nearly as severe in the 1/32-in. nylon coating of Cable 2 (figure 22) as the similar kinking damage in the 1/64-in. nylon coating of Cable 3 (figures 10 and 11).
